CONDITION APPRAISAL

UNIVERSITY OF NORTH
DAKOTA PARKING
FACILITY

GRAND FORKS, NORTH DAKOTA

FEBRUARY 4, 2016

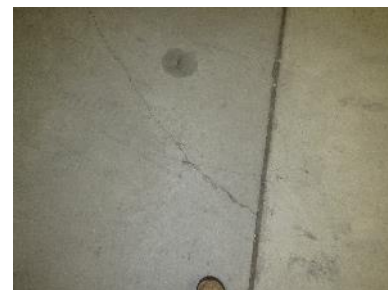
Photo 1

The slab-on-grade floors are generally in good condition and have a few cracks and spalled areas that can become trip hazards. The joints in the slab are sealed. We noticed that the ramp is supported on pile foundations, which generally indicates poor soils. The lowest level slabs are also typically pile-supported with the parking structure to limit relative movements between the slab and structure. However, these slabs are bearing on grade and may experience greater

movement, cracking and differential settlement than a typical structure. See Photo 1.

Patch damaged concrete, route and seal cracked concrete and replace damaged construction joint sealants.

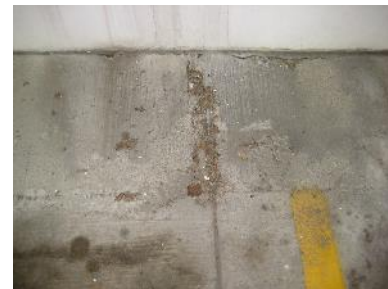
Photo 2

The parking area floors are in good condition with a few, small, isolated concrete delaminations in the cast-in-place concrete wash and curb areas, and most of the pour strip area over the inverted tee beams where the precast double tees meet. The pour strips and curbs also have the majority of the cracking. One double tee stem was observed to be damaged at the bearing. Spalling and delaminations were observed at the concrete around the connectors that are located between the spandrel panels and the double tee floor members. Refer to Photos 2 through 4.

Remove and replace delaminated concrete and repair the double tee stem. A structural review should be performed to verify that the connections between the double tees and spandrels are properly designed for their intended loads and movements. Spalled concrete should be repaired.

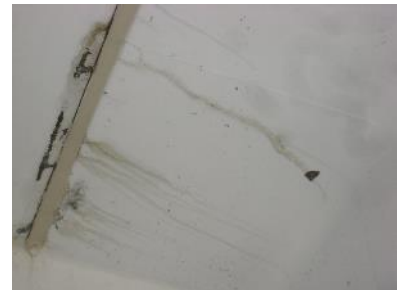
Photo 5

A few random cracks were observed in the supported parking floor slabs and at double tee stems at isolated locations. Leaking floor cracks allow direct infiltration of moisture and chlorides into the floor slab. Refer to Photos 5 and 6.

Rout and seal floor slab cracks and epoxy inject cracks in double tee stems and flanges.

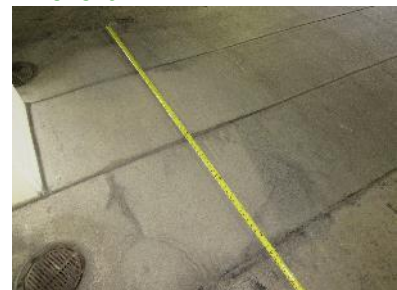
Photo 7

Construction joints in the floor slab are located between the double tee flanges and at the edges of the concrete washes, pour strips and curbs. The joints between the double tees have mostly failed and the joints are sealed at the top and bottom. The double sealant traps moisture between the tees and can cause freeze-thaw deterioration, additional chloride contamination, and premature corrosion of reinforcing steel. The joints at the washes, pour strips and curbs have minimal deterioration, but are missing at some locations. Refer to photo 7 for typical joints.

Remove and replace deteriorate sealants and add sealants where they are missing. Remove all sealant at the bottom of joints to allow moisture to freely drain.

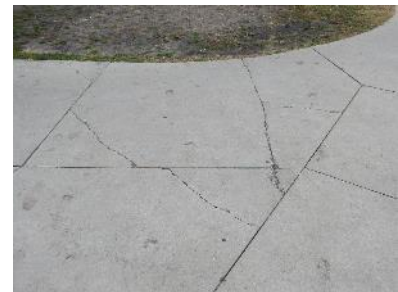
Photo 8

Paving outside of the ramp is cracking and settling at a few locations. Refer to Photo 8.

Monitor slab cracking and repair trip hazards.

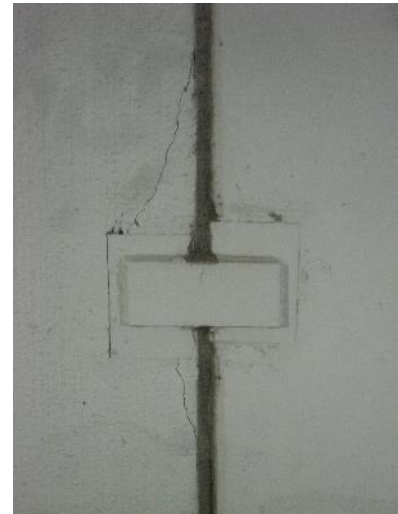
Photo 9

Concrete walls and spandrels are generally in good condition. A few areas of cracked and spalled concrete were observed at connections to the columns and structural deck. Tight, vertical cracks were observed at several locations randomly throughout. Refer to photos 9 and 10.

A structural review should be performed to verify that the connections are properly designed for their intended loads and movements. Spalled and delaminated concrete should be repaired.

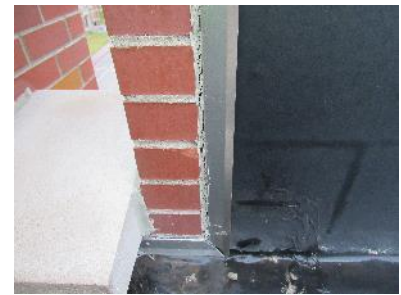
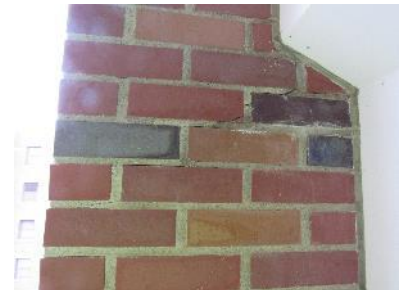
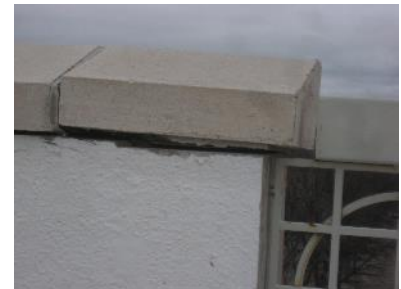
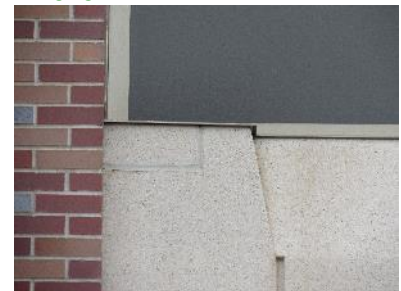
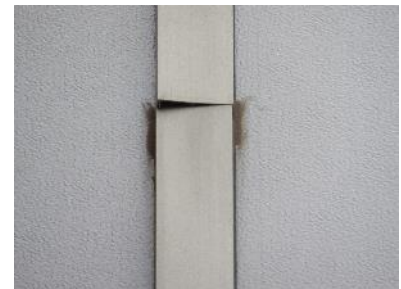
- Failing Sealants
- Cracked brick and mortar joints
- Failed precast column caps and accent bands
- Improperly sloped flashings at window sills
- Storefront/curtainwall mullion caps loosening

The sealants appeared to be at the end of their useful life and are debonding from the substrate material and cohesively failing. The cracked brick appears to be caused by minimal expansion joints between the brick and the building structure. Brick expands as it ages. The vertical stack of brick at the columns does not have relief angles and expansion joints to accommodate the movement. Our thoughts regarding the damage at the column caps and accent bands include the theory that the brick expansion is causing the damage to the caps and accent bands. Improperly sloped flashings below the windows at the south skyway are causing water to leak into the finished space of the skyway interior. Refer to photos 12 through 16.

Replace failed sealant in the next 3 to 4 years. Cut proper expansion joints into the brick and seal the joints with new, larger sealant joints. Replace cracked brick and mortar joints. Revise the window sill detail to allow the flashing to slope away from the windows. Re-fasten mullion caps that are not completely fastened at glazing systems.

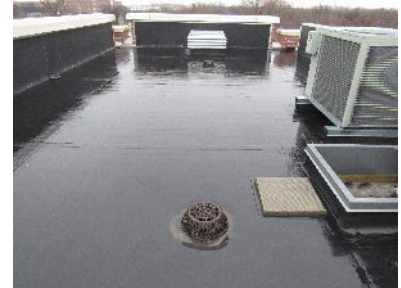
Photo 17

Roofs were not reported to leak, and indications of leaking were not observed at the interior. We understand the roofs are adhered EPDM. Flashings, primary drains and overflow drains appeared adequate. Refer to Photo 17.

Maintain roof drains and periodically observe roofing seams for damage.

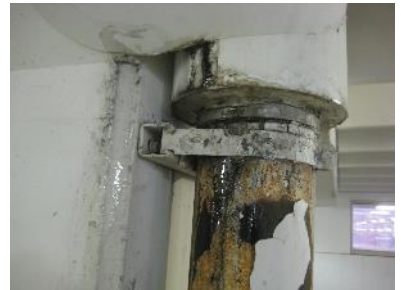
Photo 18

Floor drains and piping were observed to be in good condition and appear to be functioning as designed. Light surface corrosion was noted throughout and a few pipes were observed to be broken and leaking. Refer to Photo 18.

Replace broken drain lines. Clean pipes on an annual basis. Monitor, clean and paint as needed.

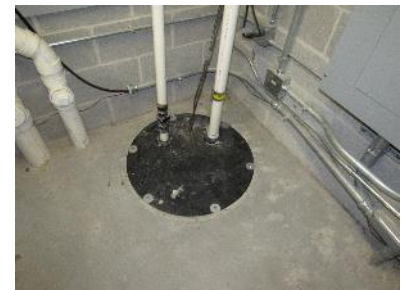
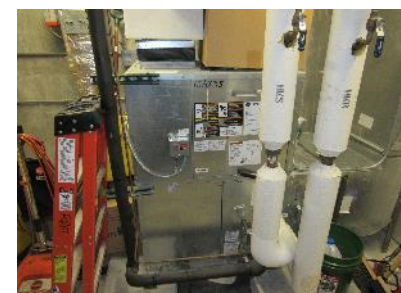
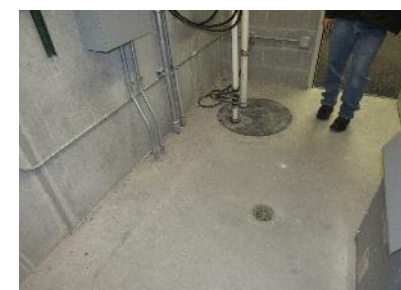
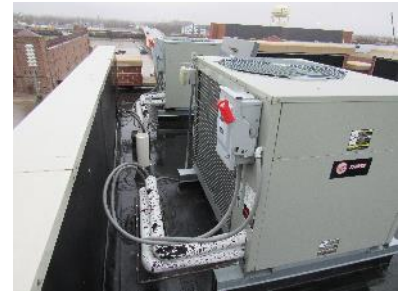
Mechanical systems were generally observed to be in good condition. There were no reported problems with any of the mechanical systems at the time of the evaluation. Plumbing and ventilation systems were observed to be operating properly. Each of the mechanical rooms adjacent to the elevator shafts has a floor drain. One of these drains was observed to be covered with tape. Refer to photos 19 through 22.

Monitor systems for performance deficiencies. Flush mechanical room floor drains with water when the ramp drains are flushed.

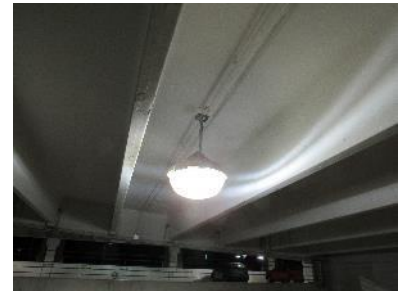
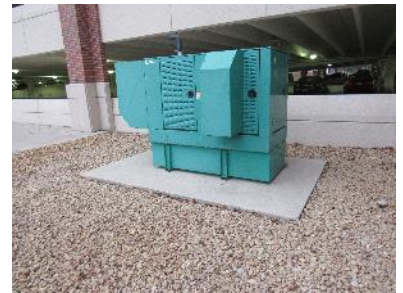
Electrical systems were generally observed to be in good condition. Illuminance and lighted emergency exit signage is generally in compliance with requirements. The fire alarm system appears to be in general compliance with requirements. The parking facility has an emergency generator at the northeast corner. Refer to photos 23 and 24.

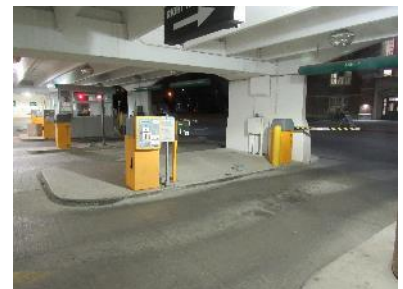
Photo 25

The PARCS equipment was observed to be functional. It is our understanding that the PARCS system is going to be replaced. Refer to Photo 25.

Walker is available as an owner's representative to evaluate new systems and system options upon request.
