CONDITION APPRAISAL

UNIVERSITY OF NORTH
DAKOTA PARKING
FACILITY

GRAND FORKS, NORTH DAKOTA

FEBRUARY 4, 2016

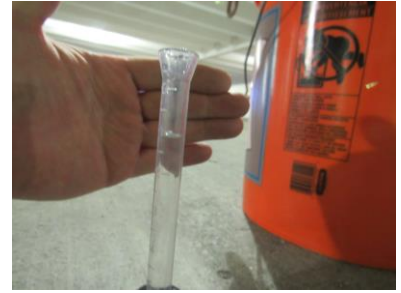
Photo 26

Rilem tubes were used to test the absorption of the concrete surface. The concrete absorbed approximately 1 mL (3/4 inch) of water over 20 minutes. It is our opinion that the precast concrete deck is moderately absorptive and should have a penetrating water-repellant sealer installed.

We recommend installing water-repellant sealer at a small area to test the effectiveness of the sealer prior to coating a large area.
